**CULTURAL RESOURCES SURVEY OF
THE SCE&G SALUDA DAM COMPLEX,
LEXINGTON COUNTY, SOUTH CAROLINA**

CULTURAL RESOURCES SURVEY OF THE SCE&G SALUDA DAM COMPLEX, LEXINGTON COUNTY, SOUTH CAROLINA

Prepared By:
Michael Trinkley, Ph.D.
and
Nicole Southerland

January 8, 2001
Revised September 7, 2001

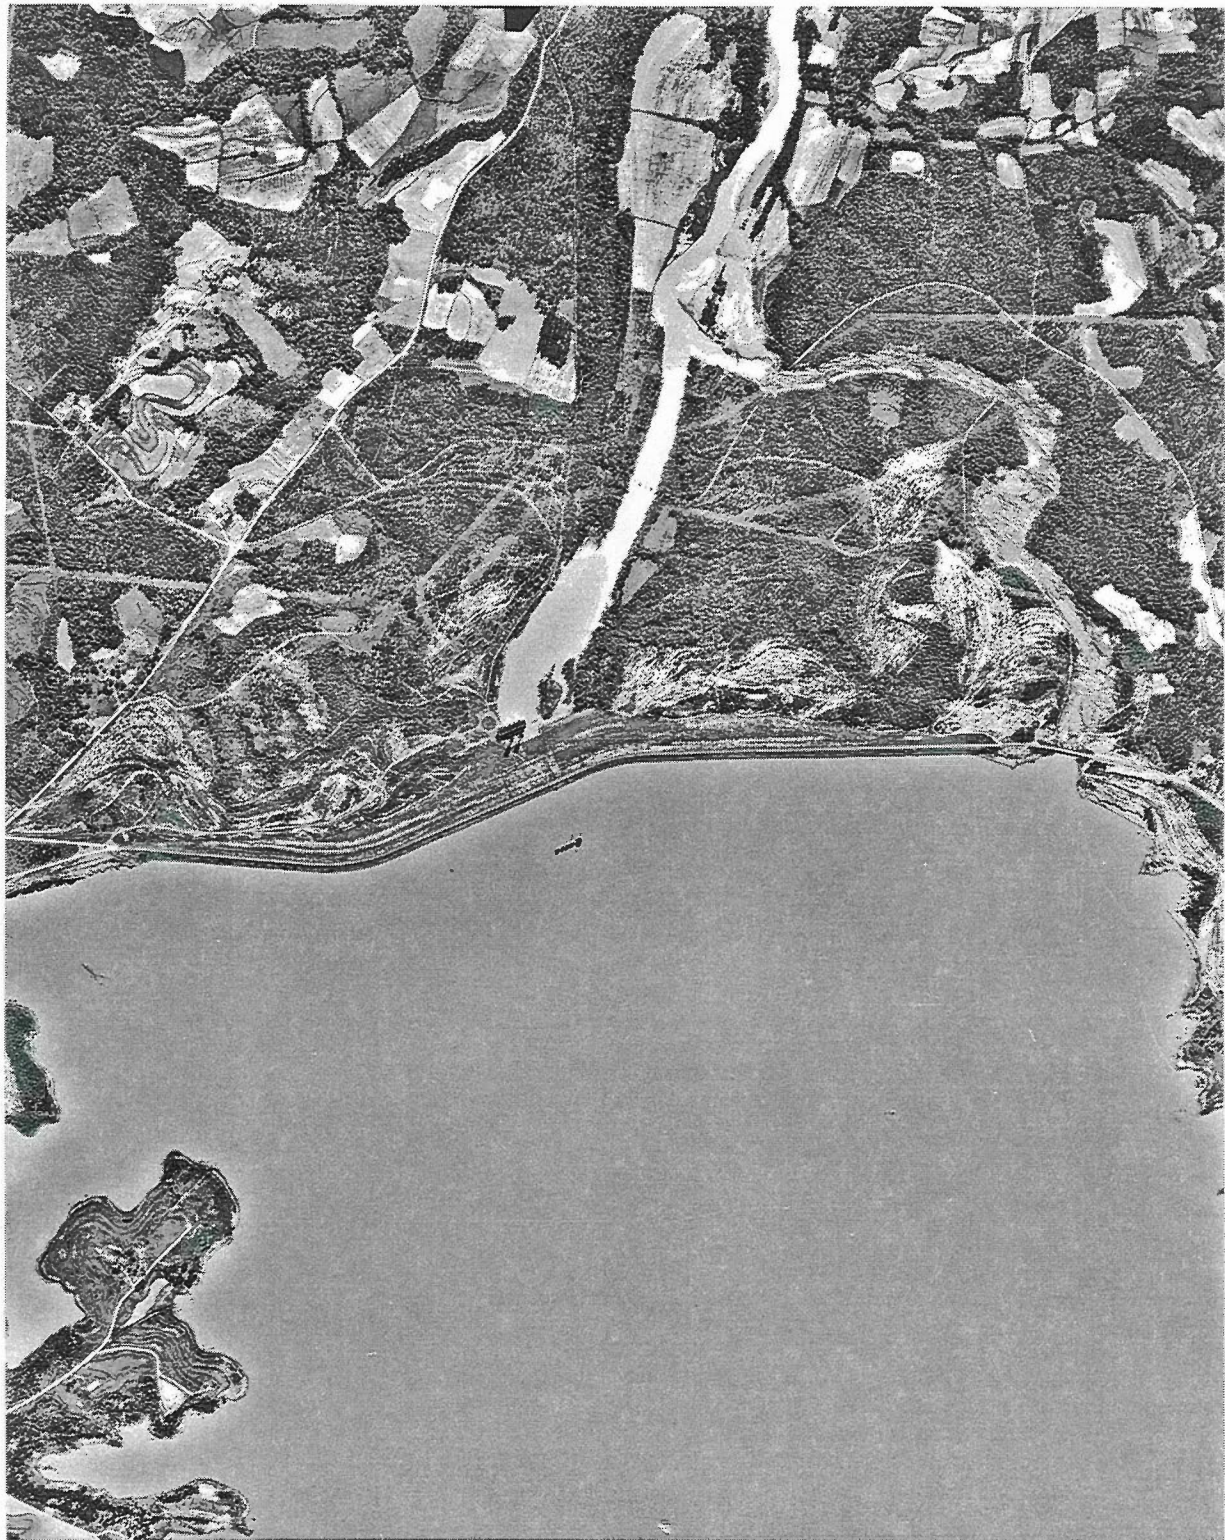
Figure 39. Dam complex and vicinity in 1943 (USDA, ASX-9C-69).

This aerial also reveals that the damage wasn't limited to the dam complex. To the south, around the lake edge, there is evidence of extensive clear cutting and borrow activity. The same can be seen northwest of the dam, at the lake edge. All of this may be the result of additional work conducted on the dam in the 1930s. The image also reveals that the Lexington Water Power Company structures northwest of the dam, including the chapel, administrative building, and nine houses, are still all present and seem well cared for. As previously discussed, plant personnel lived in this "village" for a number of years, with SCE&G dismantling the village only 12 to 14 years ago.

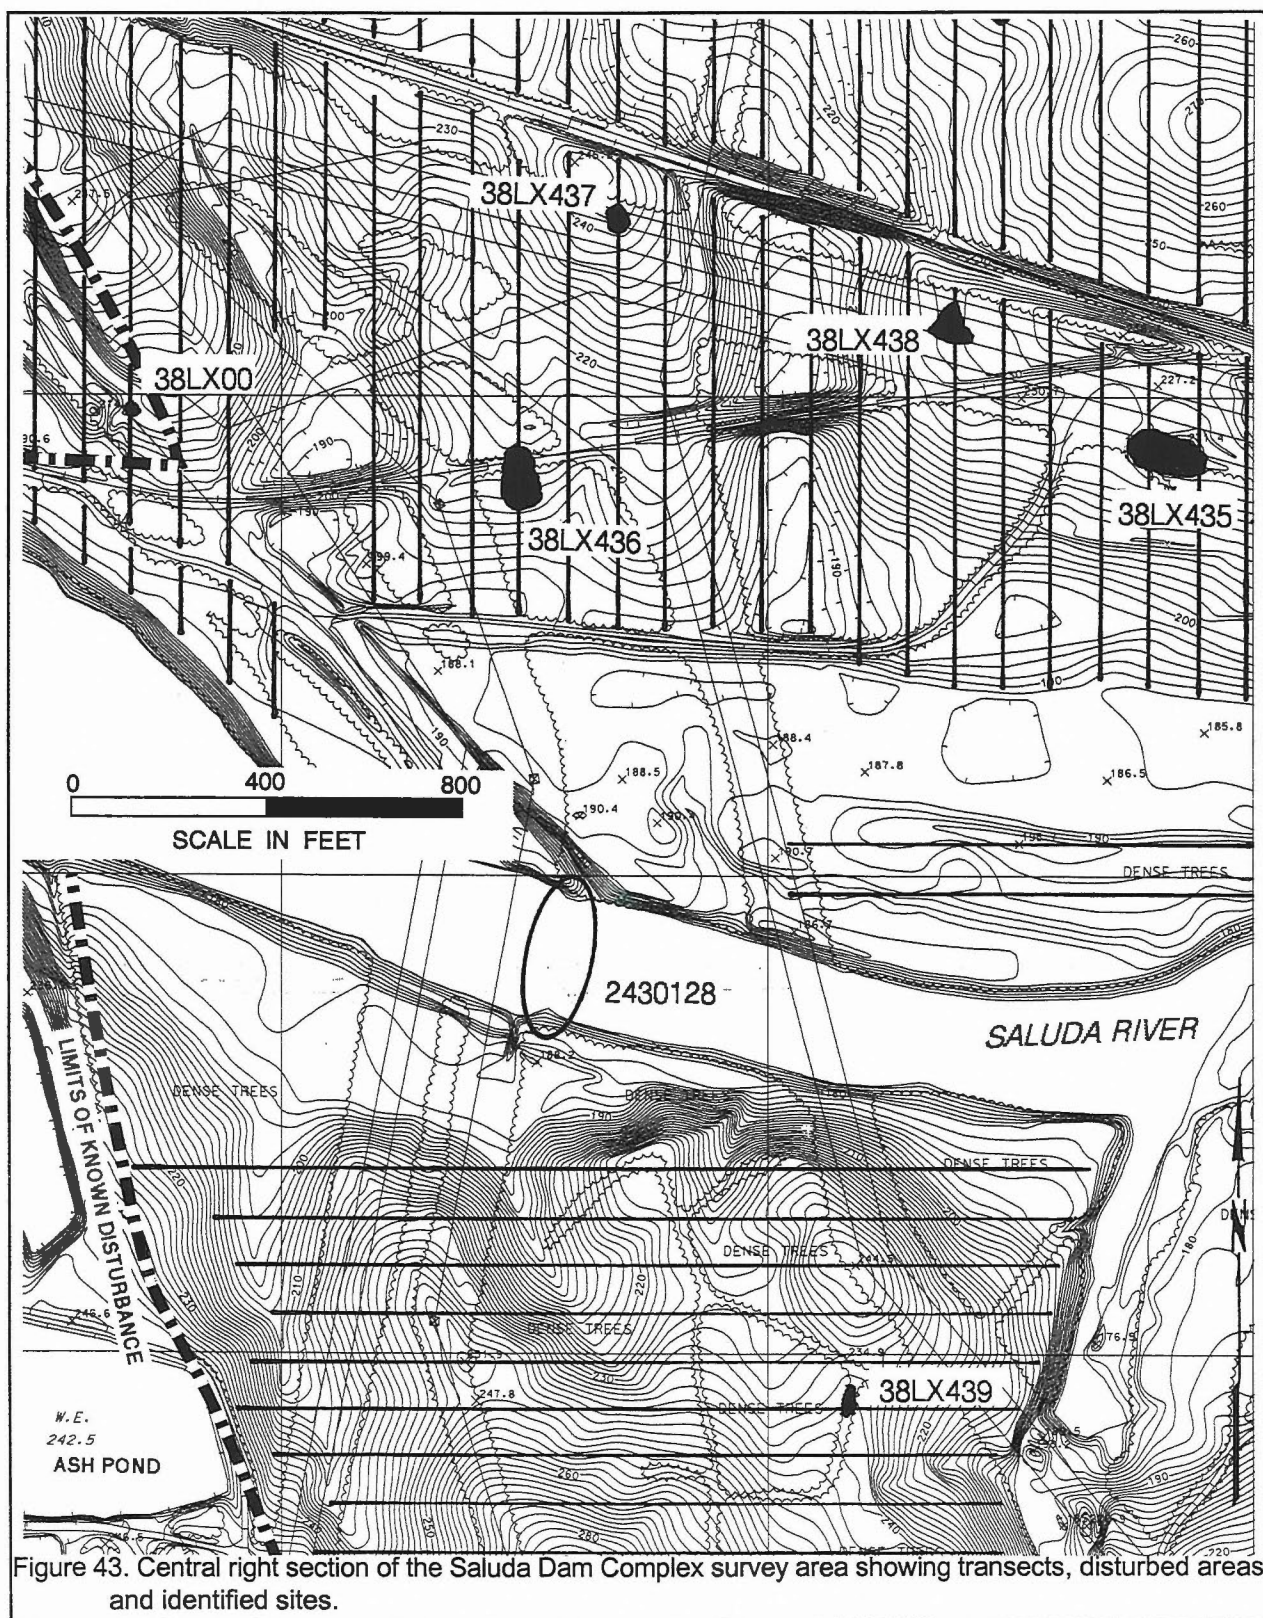
Figure 43. Central right section of the Saluda Dam Complex survey area showing transects, disturbed areas, and identified sites.

These eliminated areas are shown in Figures 40-45. The elimination of the disturbed and floodplain areas left 250 acres of the Saluda Dam Complex for the survey and the methods used for that survey and the other three project areas are described below.

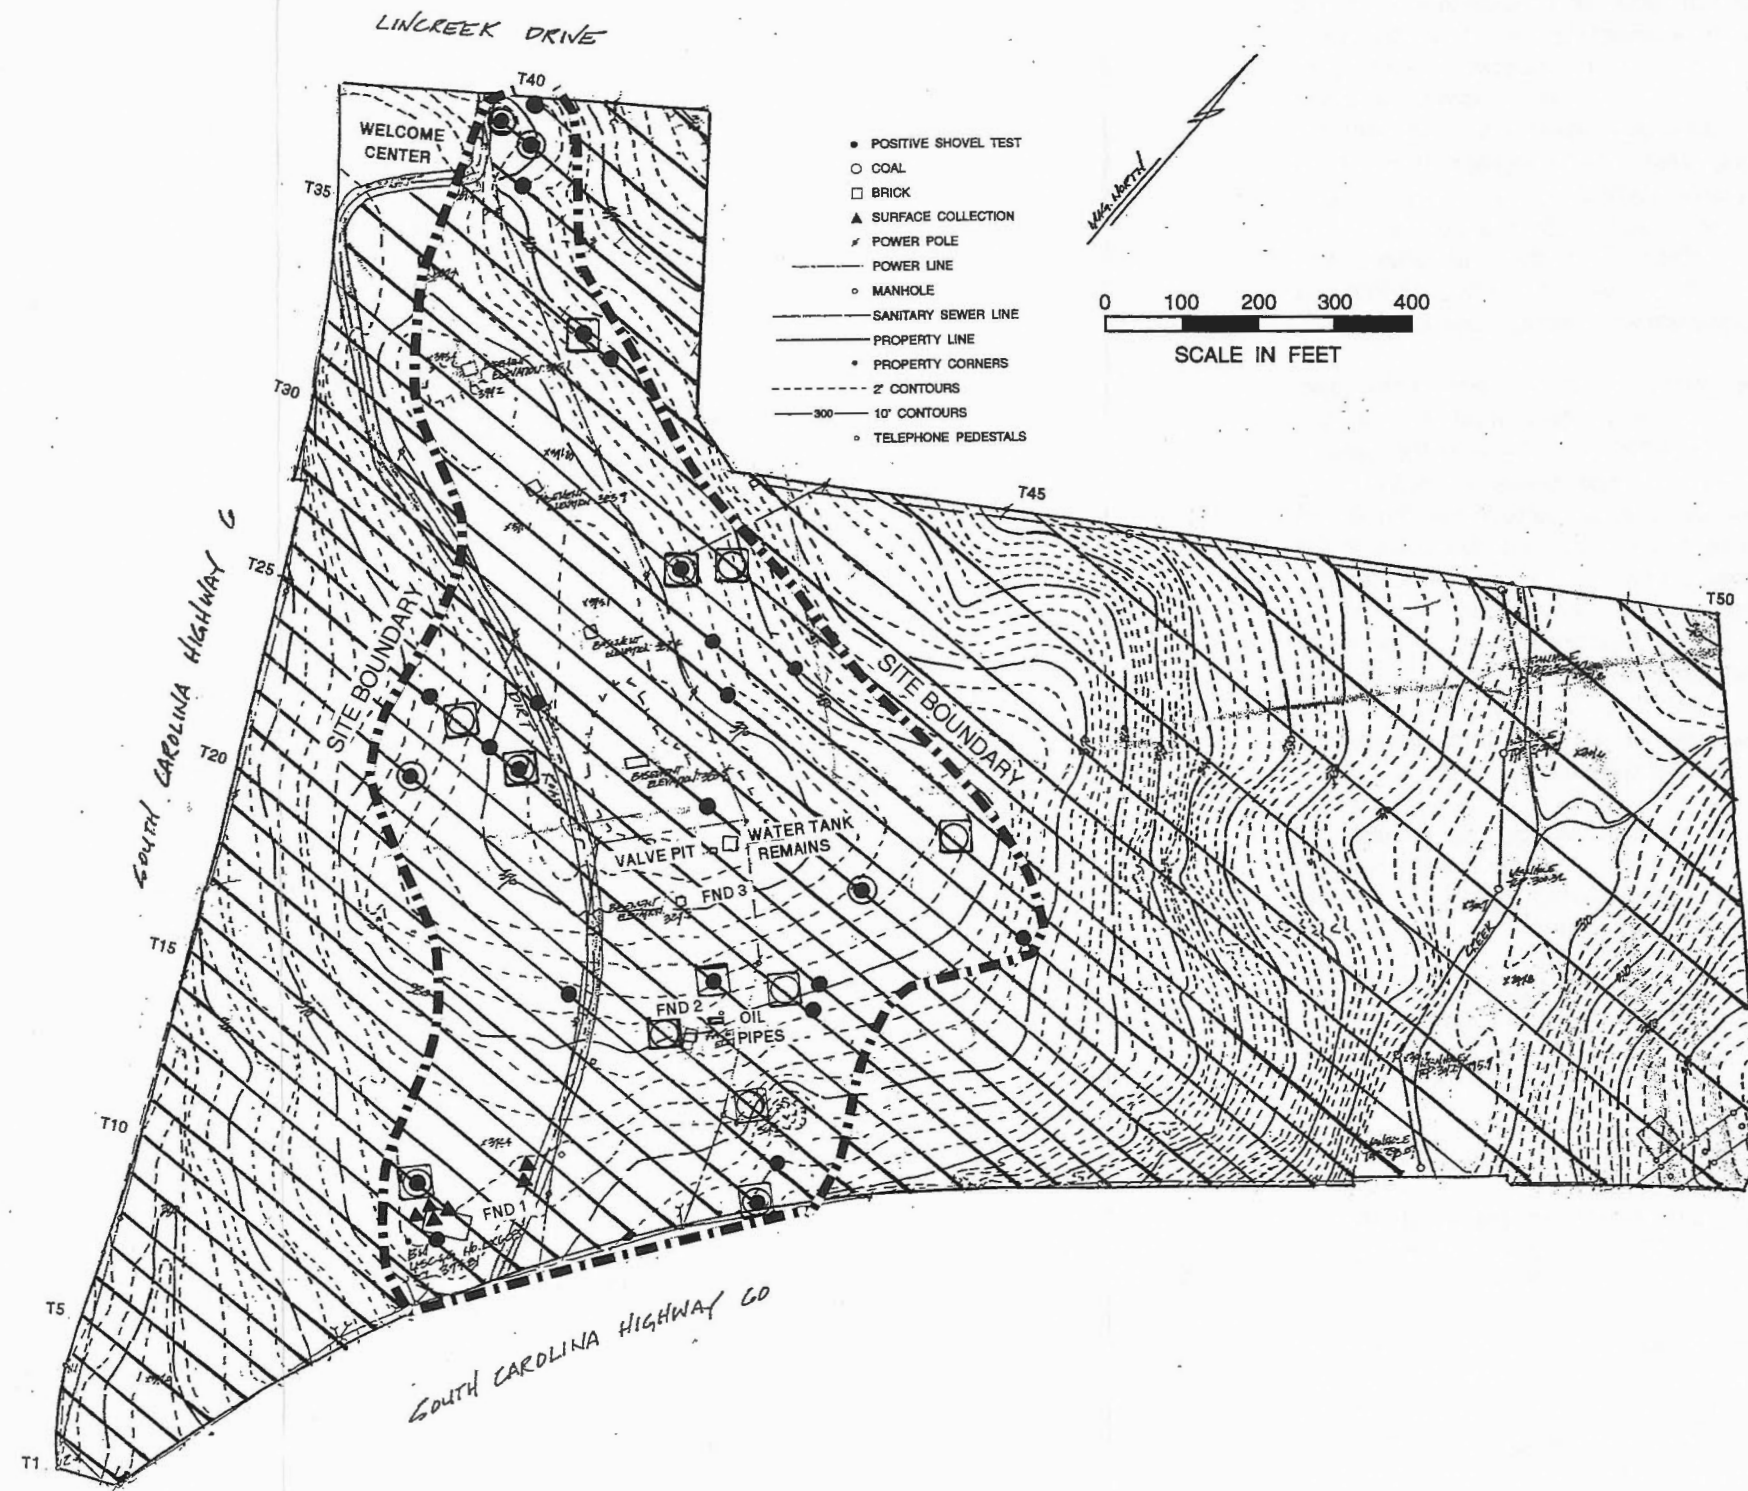
Figure 46. Saluda Dam Village survey tract showing survey transects, site boundaries, and features.

The site boundaries (see Figure 46) were based both on the distribution of subsurface and surface artifacts, as well as the distribution of obvious features, such as the basement ruins, water tank, valve box, and various brick concentrations. Ultimately the site boundaries were established at approximately 700 feet east-west by 1,500 feet north-south. The road boundary to the south is historic; the boundaries to the east and west were likely associated with the topography and the absence of buildings on these

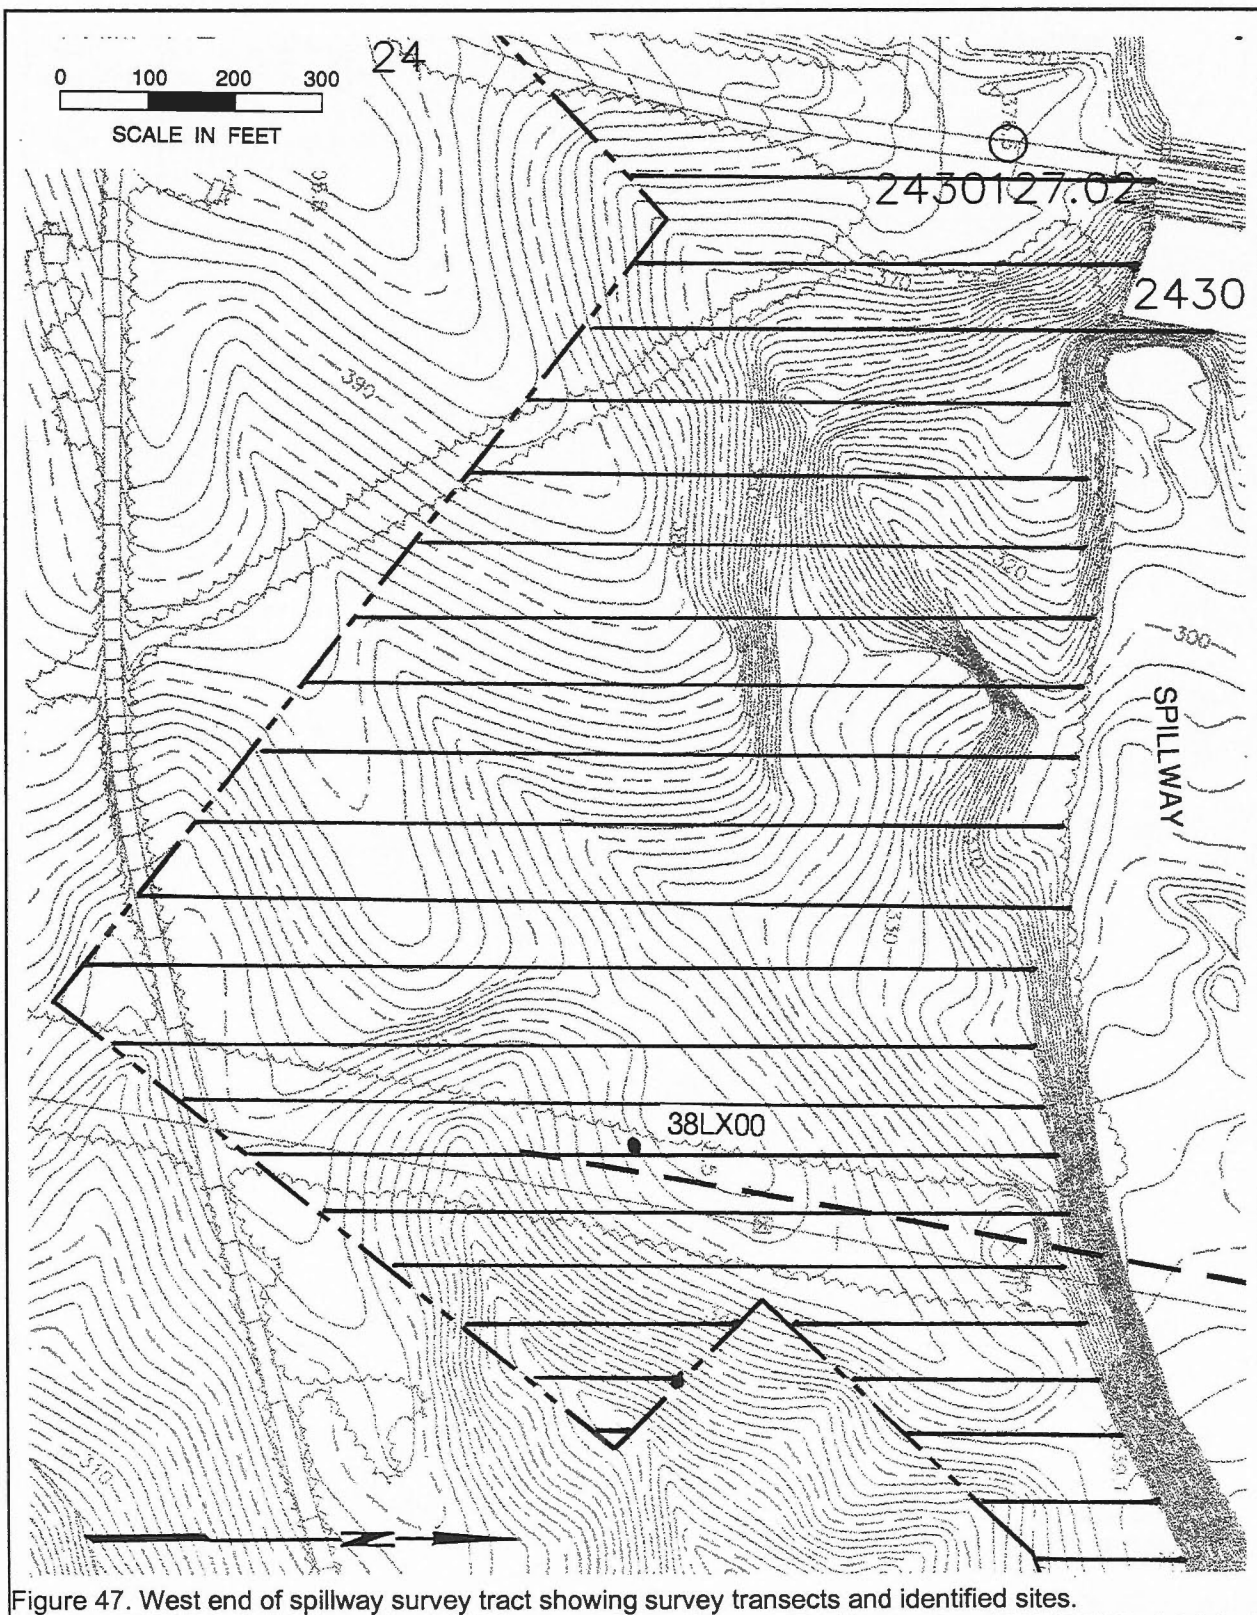
Figure 47. West end of spillway survey tract showing survey transects and identified sites.

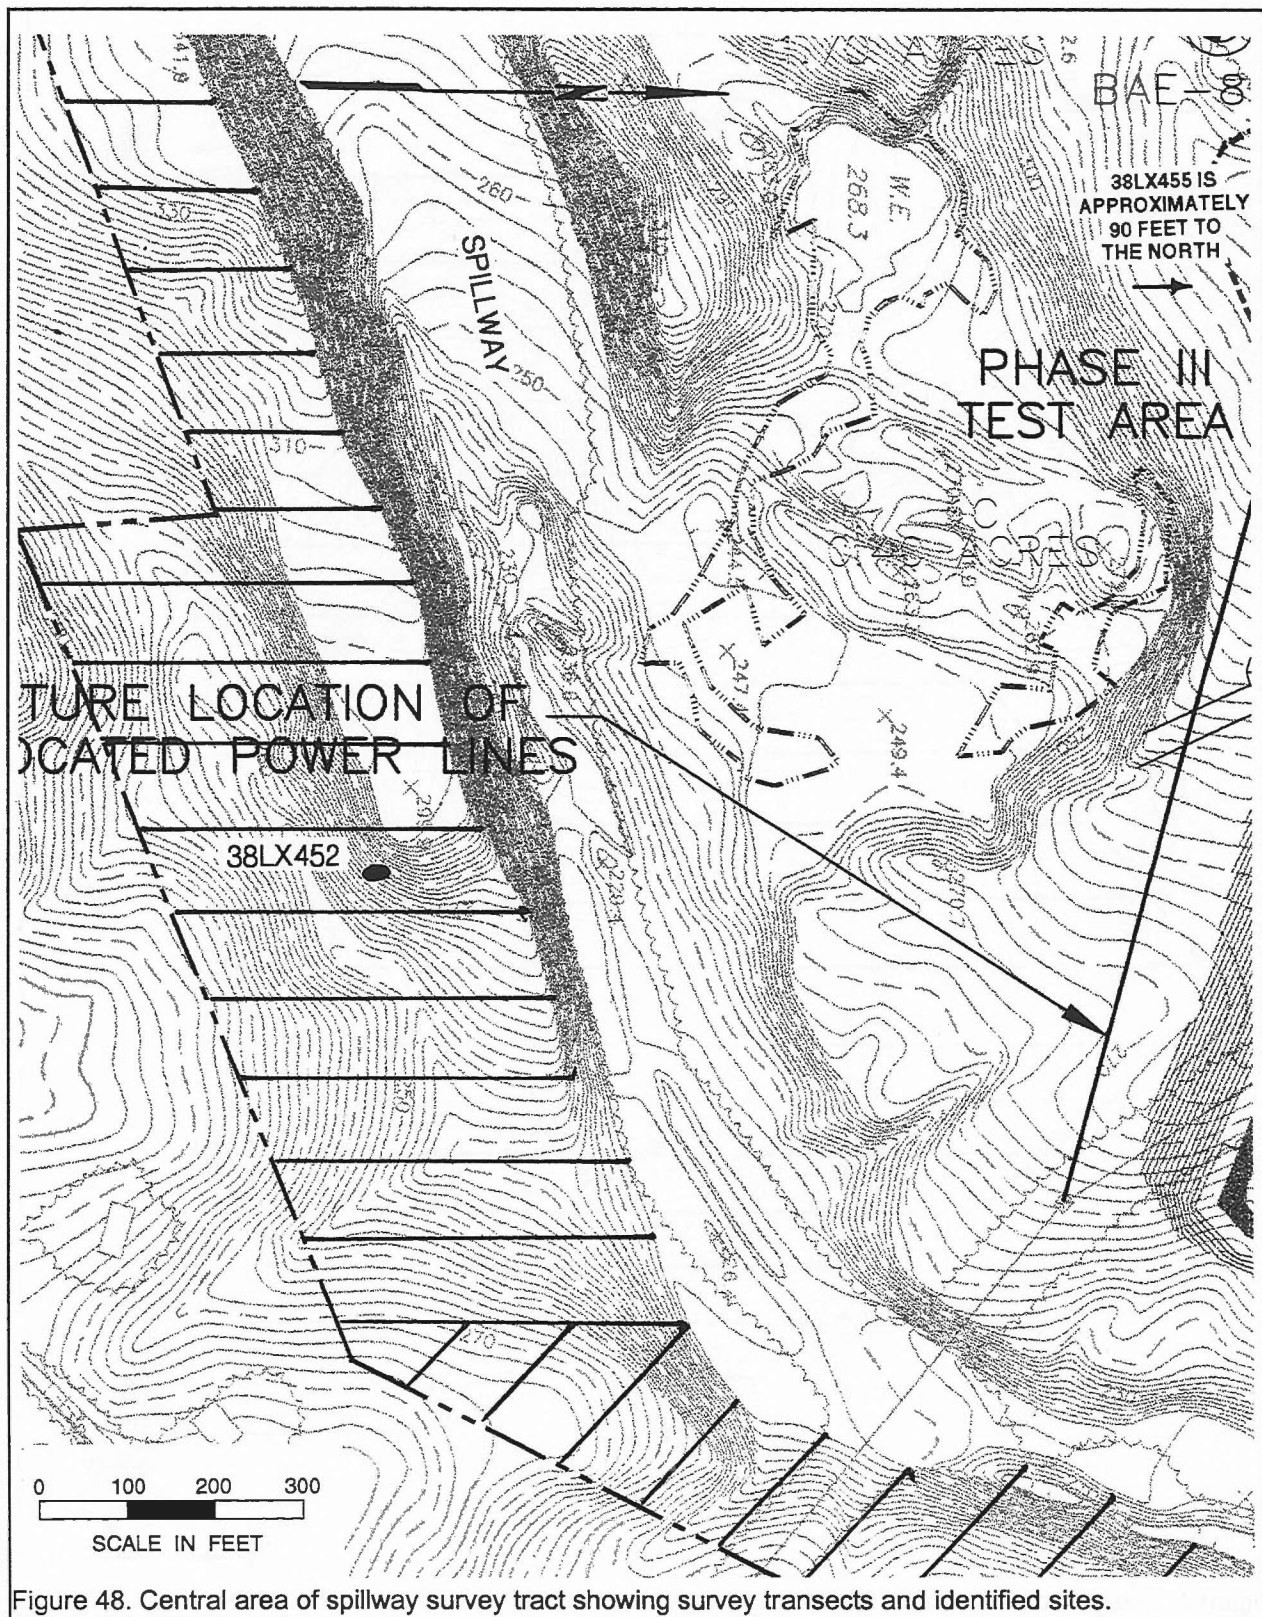
Figure 48. Central area of spillway survey tract showing survey transects and identified sites.

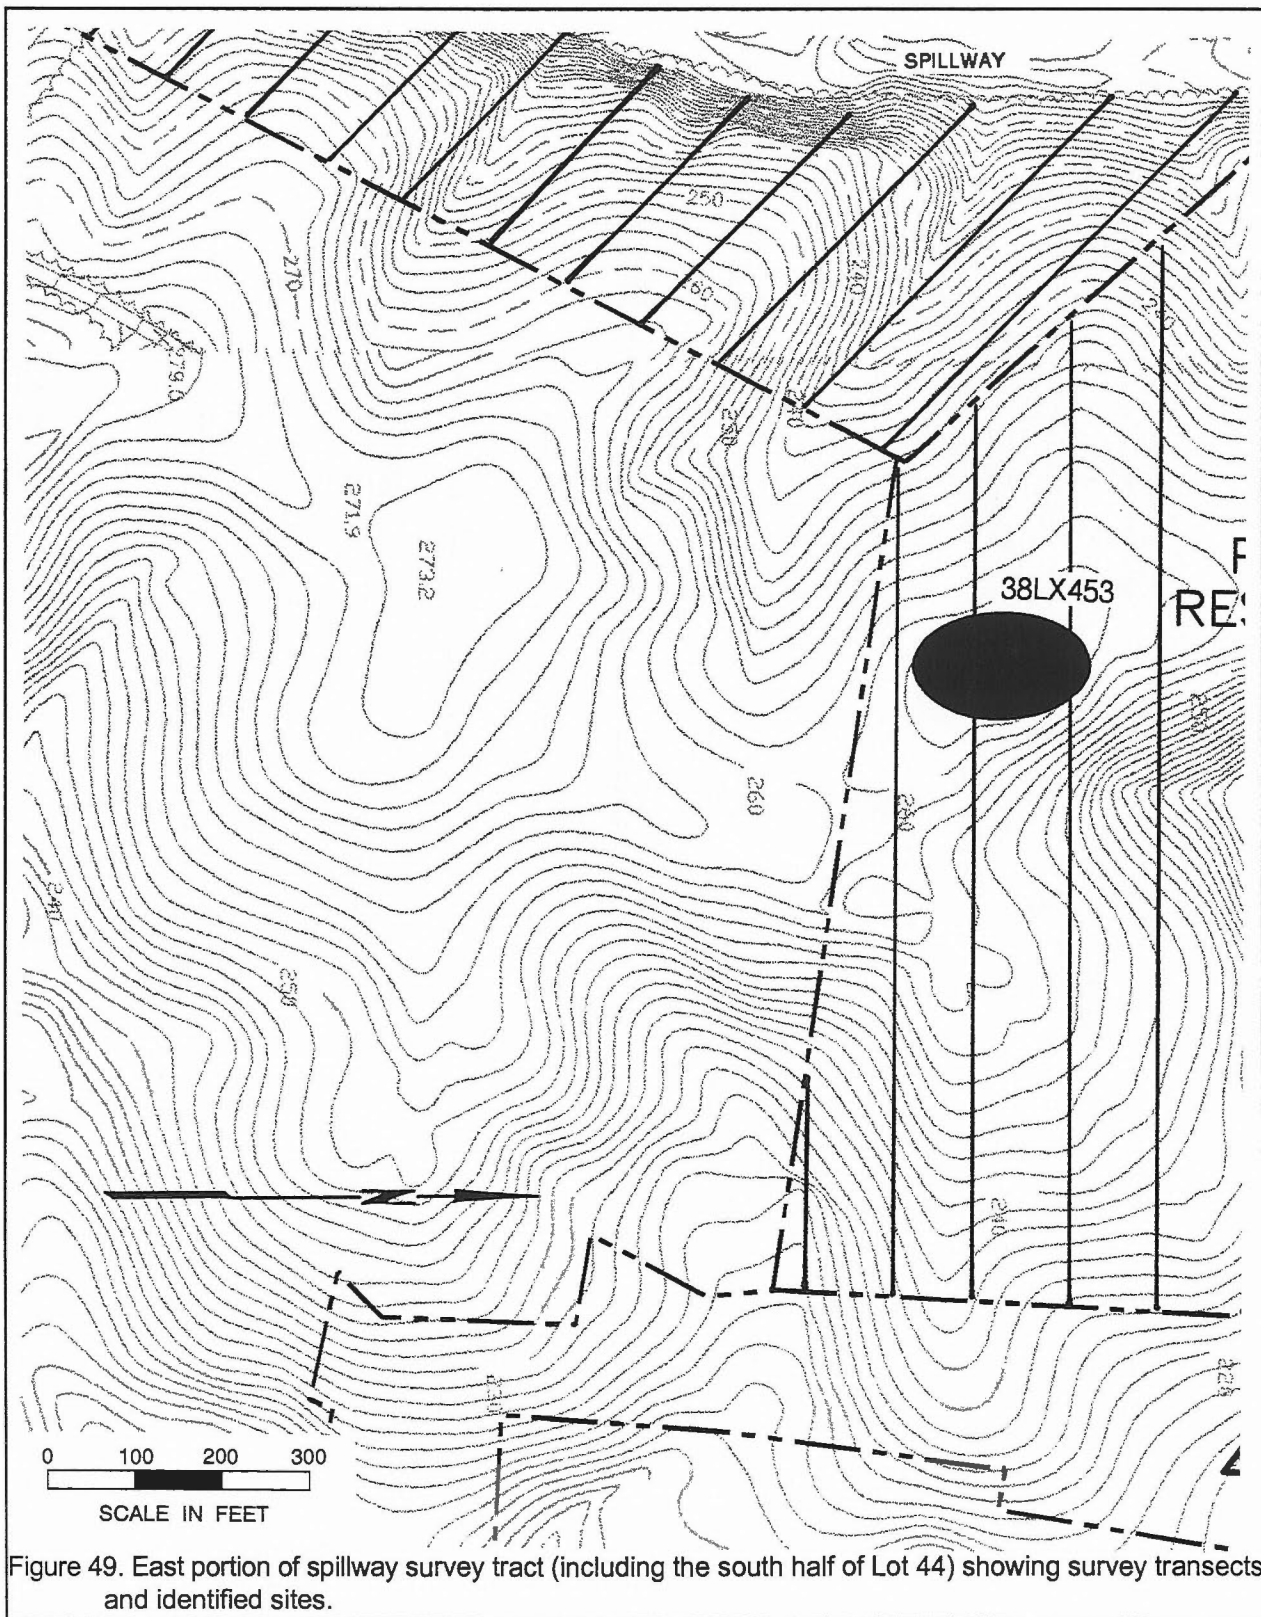
Figure 49. East portion of spillway survey tract (including the south half of Lot 44) showing survey transects and identified sites.

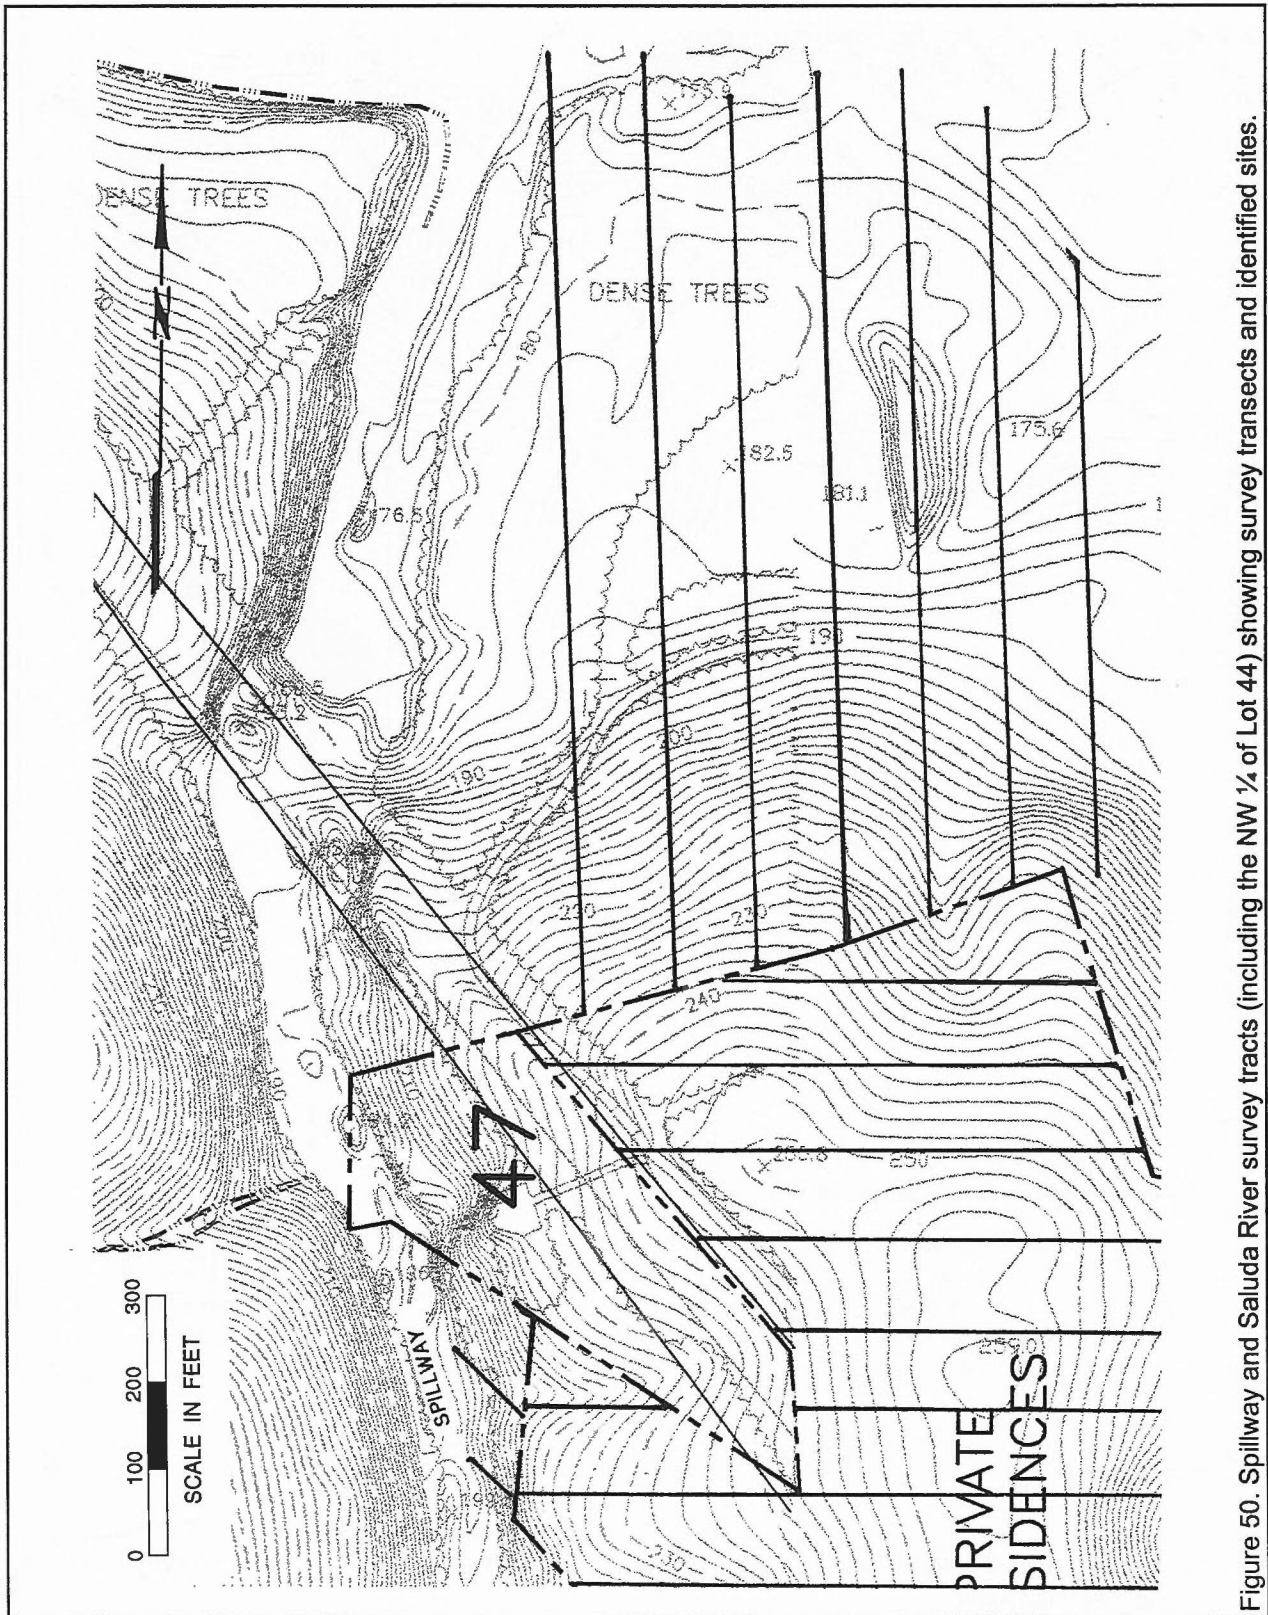
Figure 50. Spillway and Saluda River survey tracts (including the NW 1/4 of Lot 44) showing survey transects and identified sites.

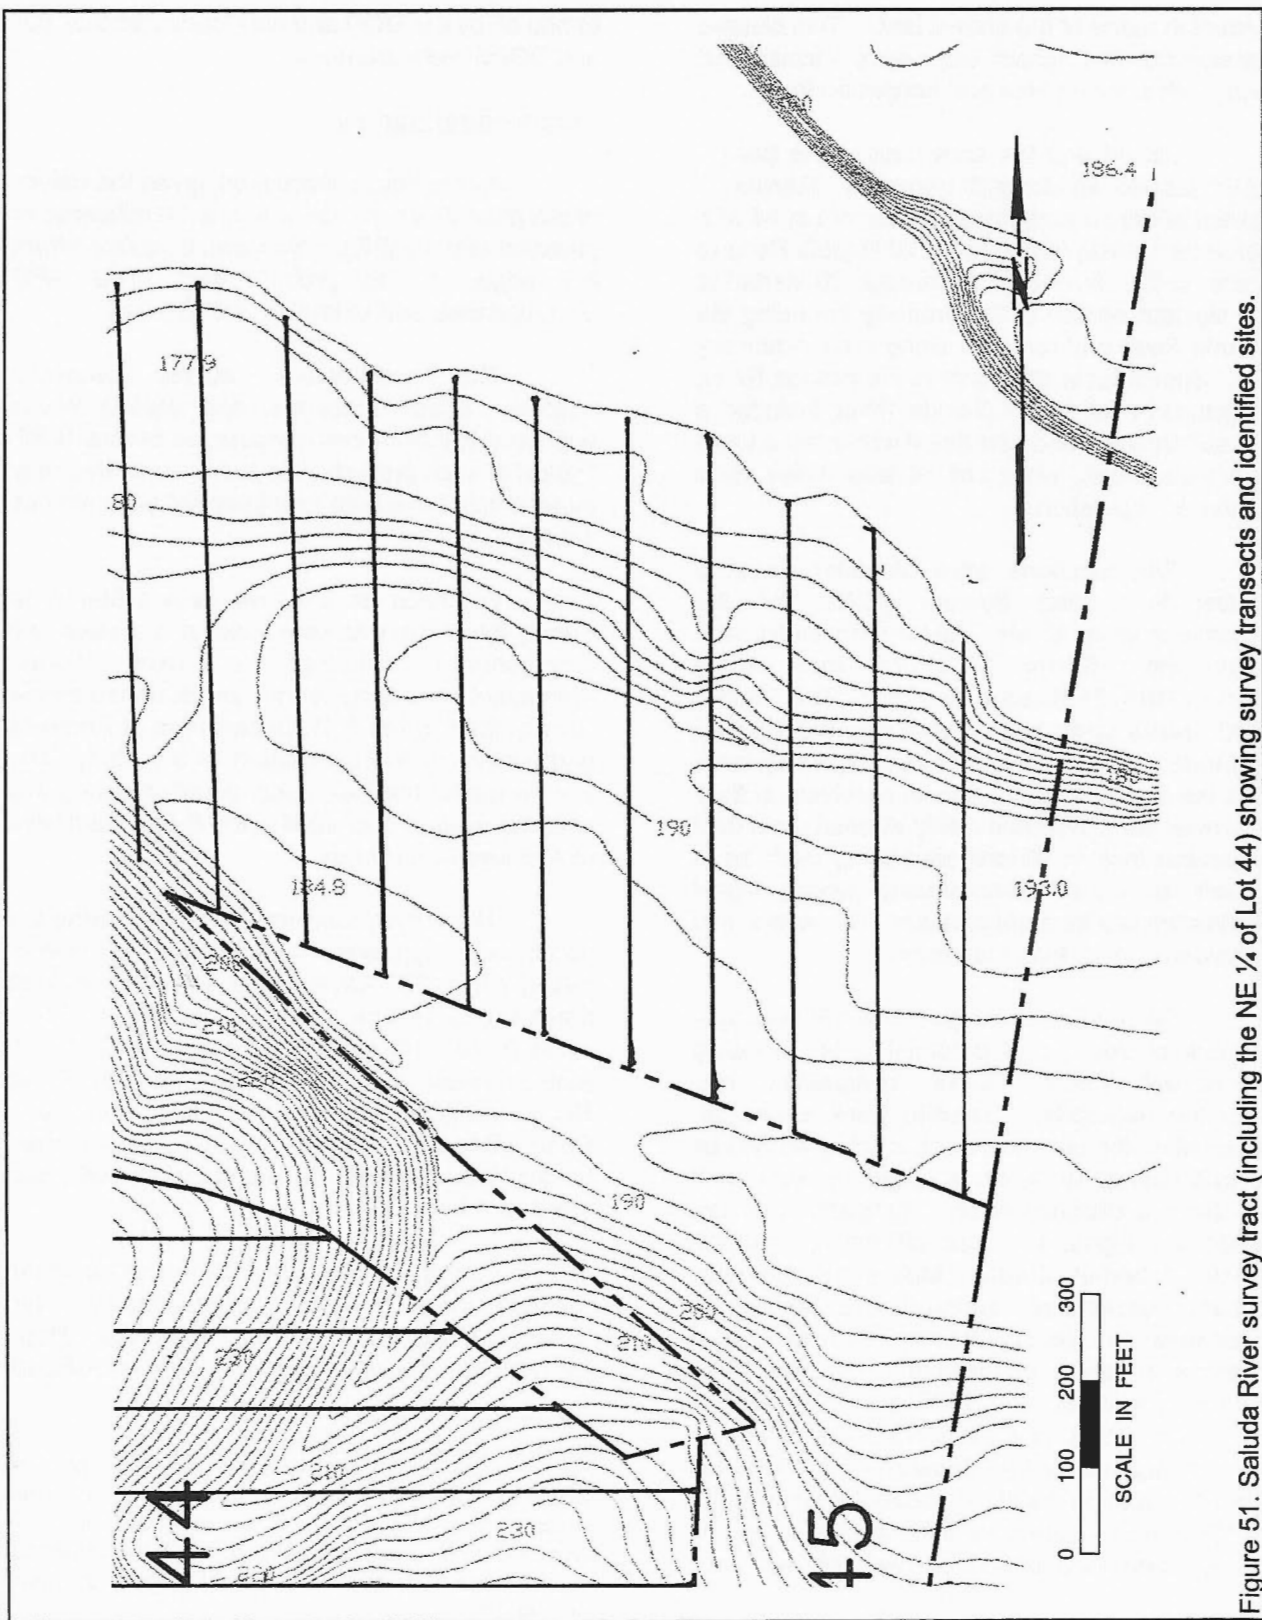
Figure 51. Saluda River survey tract (including the NE 1/4 of Lot 44) showing survey transects and identified sites.

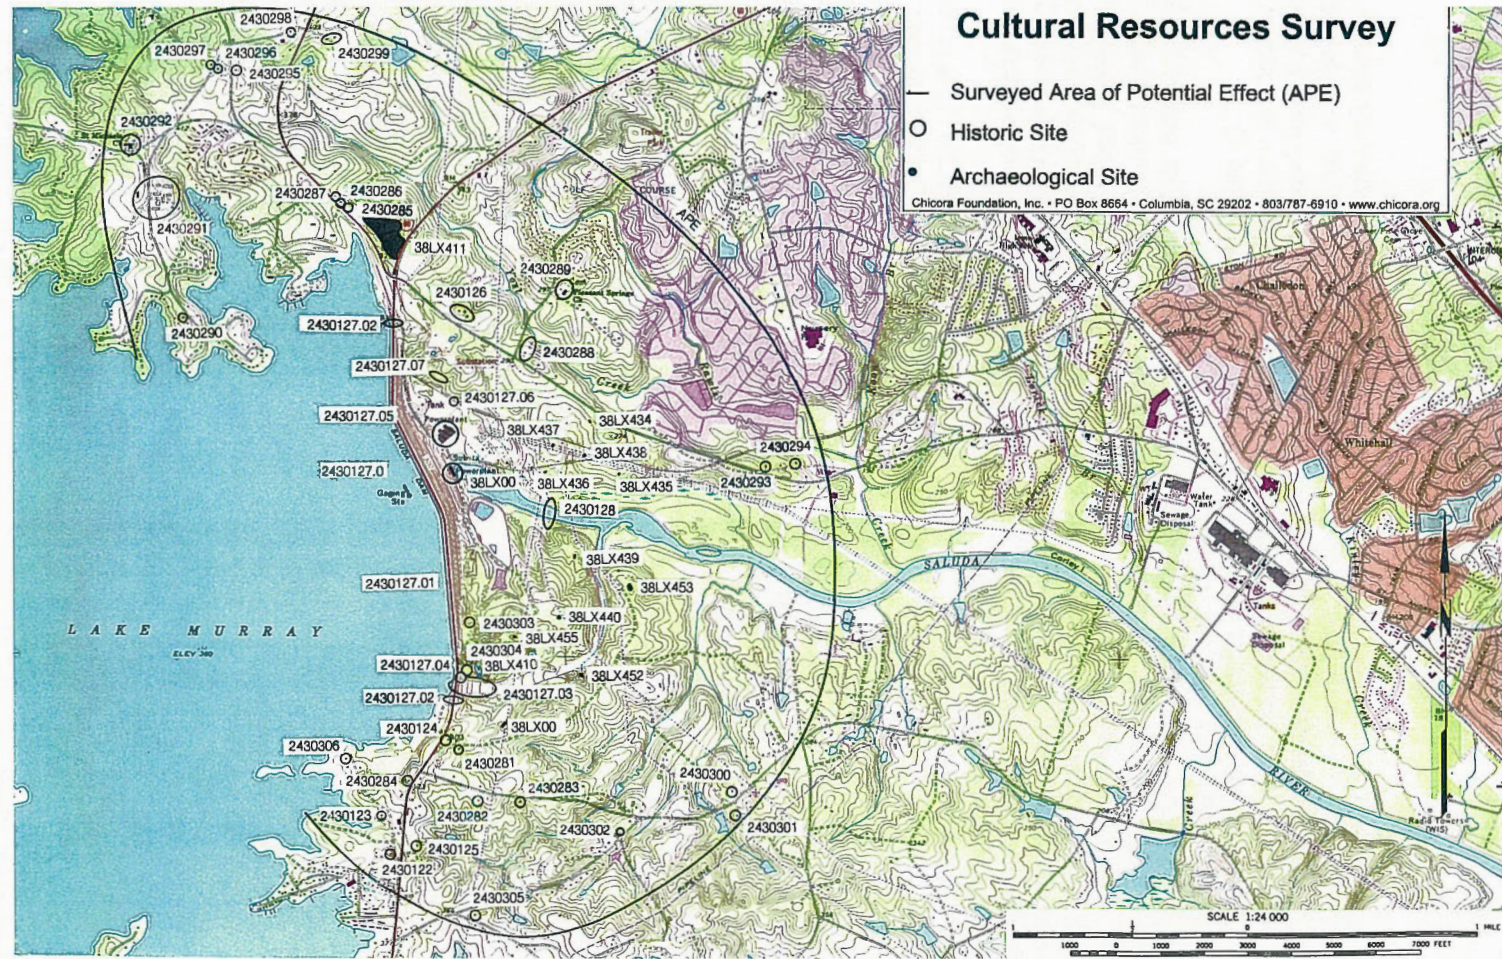
Figure 52. Cultural resources identified within the APE of the Saluda Dam Complex survey area.

Site 38LX434 is a historic refuse scatter measuring 140 feet north-south by 60 feet east-west, yielding an scatter of about 8,400 feet² (Figure 52). The site is located around and west of a north-south logging road about 300 feet south of Bush River Road on the north side of the Saluda River. The central UTM coordinates are E480930 N3768214 (NAD27 datum) and the elevation is about 250 feet AMSL on a southwest facing ridge nose or side slope. This area was in relatively dense forest at the time of the survey, with an overstory of pine and an understory of scrub hardwoods (typical of areas without controlled burns). The pines were about 30 years old and represent self-seeded trees which had re-established after the last logging episode. Originally this area seems to have been at the edge of cultivated fields. There is no indication of

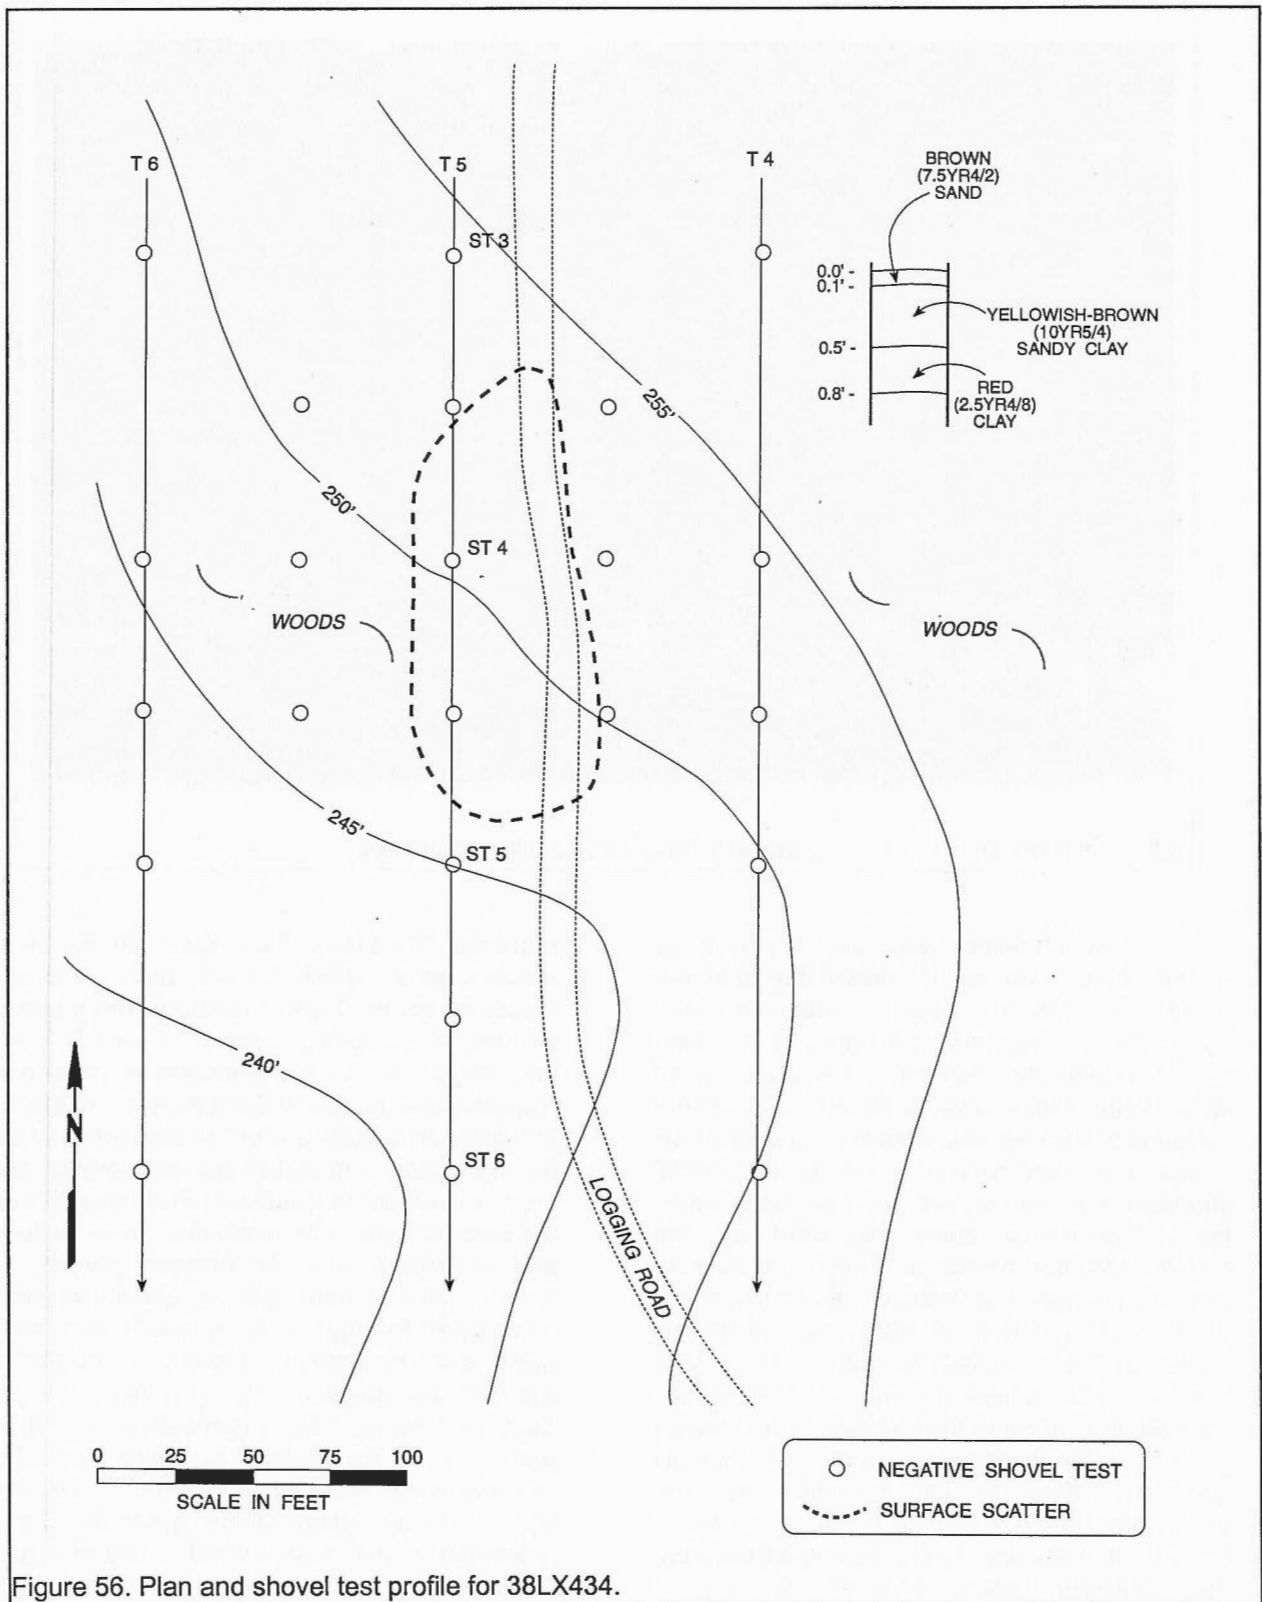
Figure 56. Plan and shovel test profile for 38LX434.

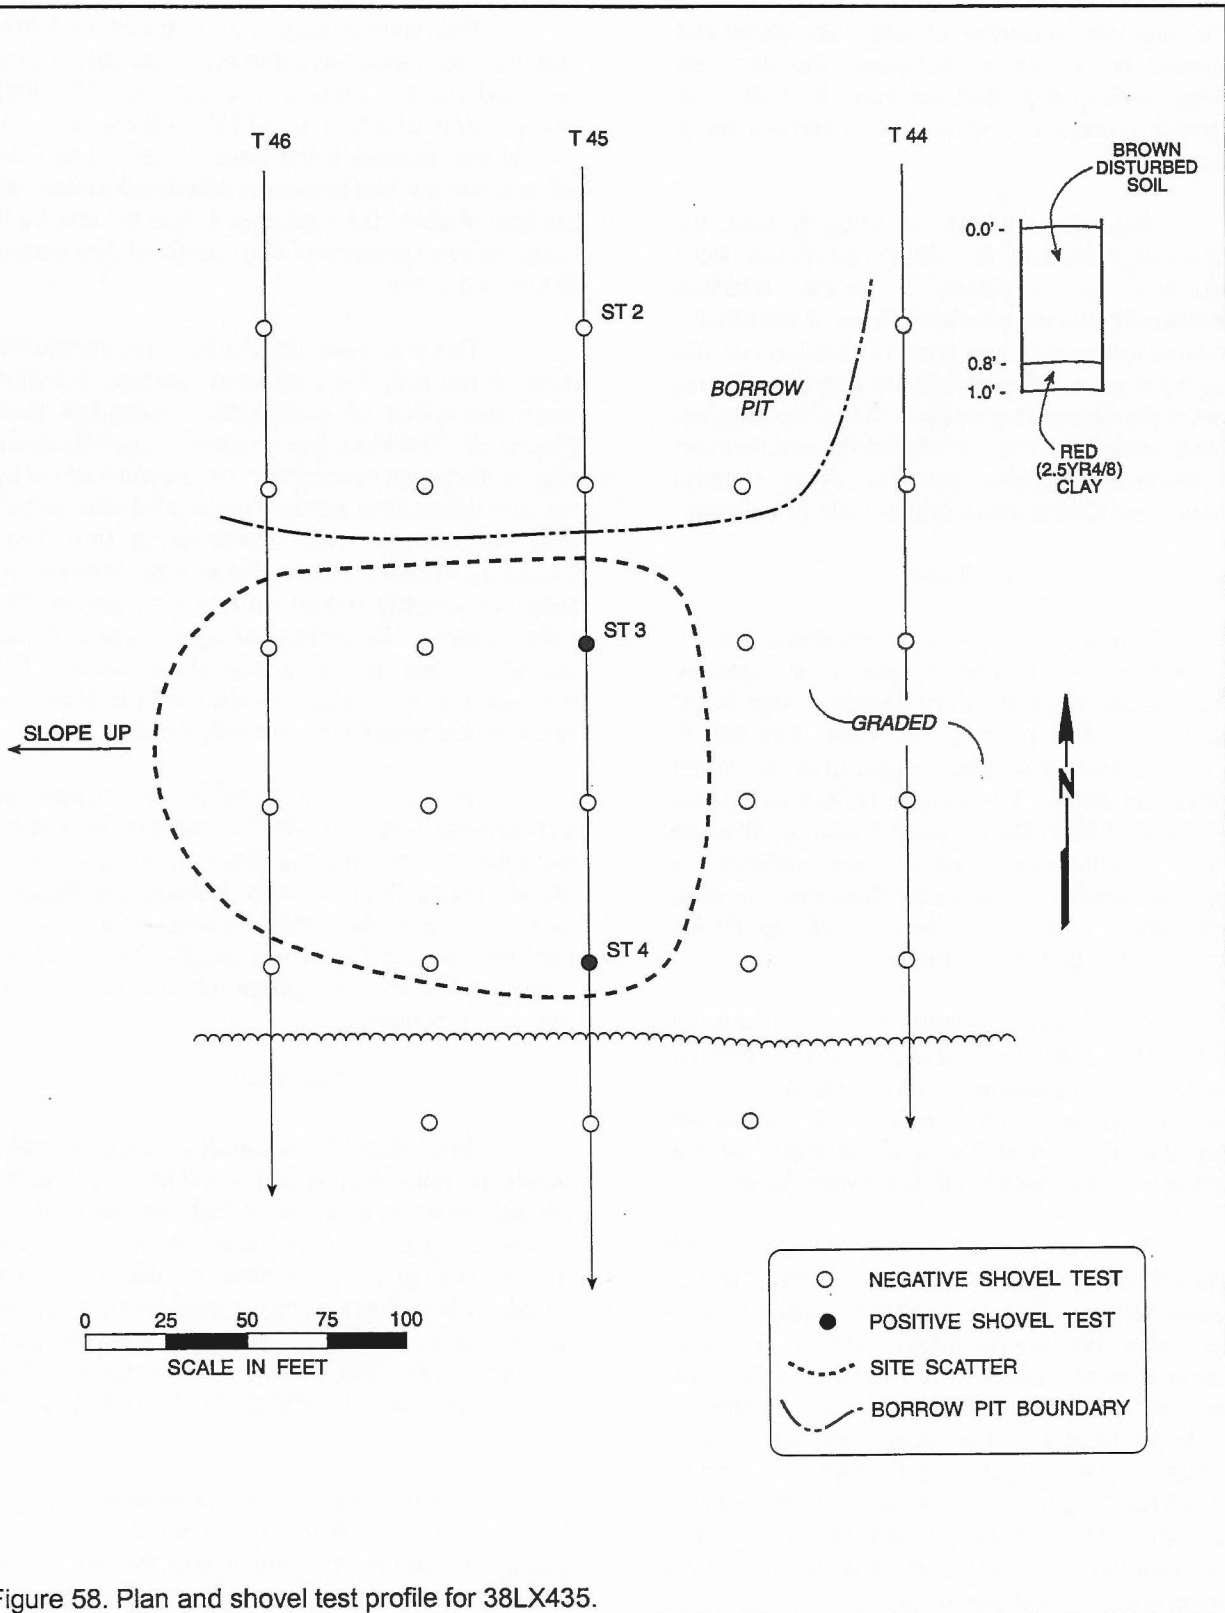
Figure 58. Plan and shovel test profile for 38LX435.
